THE DOUGLAS PROJECT

A Comprehensive Report on the Planning,
Design, Construction, and Initial Operations
of the Douglas Project

TECHNICAL REPORT NO. 10

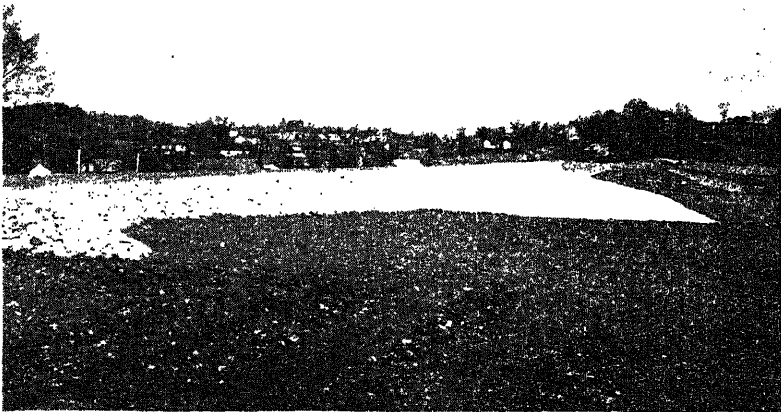
FIGURE 11.—Dandridge dike, showing a portion of the town in the background.

The two creeks flowing through the town drain, in all, 550 acres. They join near the center of the business district to flow through a narrow defile into the French Broad River. The protective dike that was built across the lower end of creek valley left the town practically undamaged except for nine low-price residences and two small business establishments; also, state and county roads required only minor adjustments to accord access to the new county bridge across the river at Dandridge. Minor adjustments were necessary to the existing street, water, and sewer systems in the town. Figure 11 shows the completed dike and a portion of the town of Dandridge in the background.

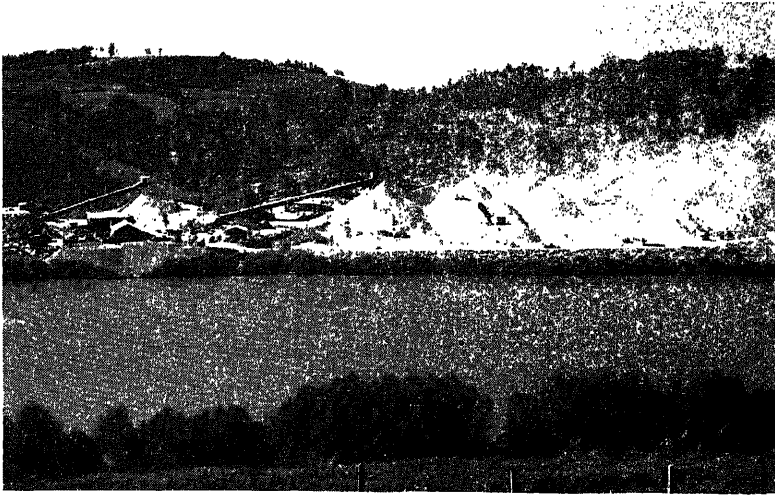
FIGURE 46.—Aggregate plant.

The principal units of the construction plant in the final layout were all located on the right bank of the river downstream from the dam (see fig. 45). The aggregate processing plant consisted of two quarries, the crushing and sizing plant with one primary crusher, four secondary crushers, one rod mill, screens, and five stackers for storing aggregates and sand (see fig. 46). This part of the construction plant was installed and operated by the contractor. Figure 47 shows the flow diagram for the contractor's aggregate plant. The stock pile contained four sizes of aggregates and one size of sand with total storage capacity of 50,000 tons. The stock pile was protected against high water by a dike with the top at elevation 890 and was located over a timber reclaiming tunnel. By a system of five belt conveyors, material was carried to the mixing plant which was located at the north end of the construction bridge (see fig. 48).

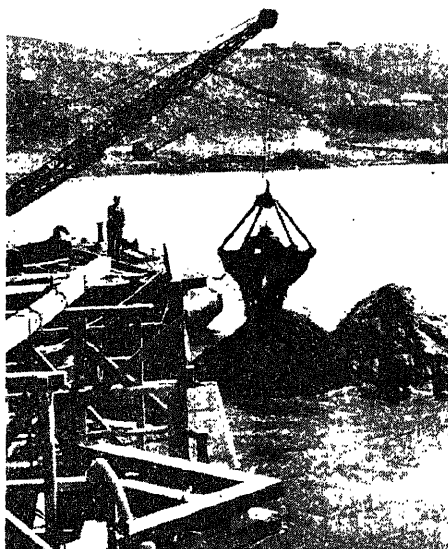
FIGURE 53.—Access bridge. Excavation for crib foundation.

The timber cribs which supported the bents were built to elevation $873 \pm$, which permitted a discharge of 6,000 cubic feet per second during their construction. They rested on rock and were constructed of

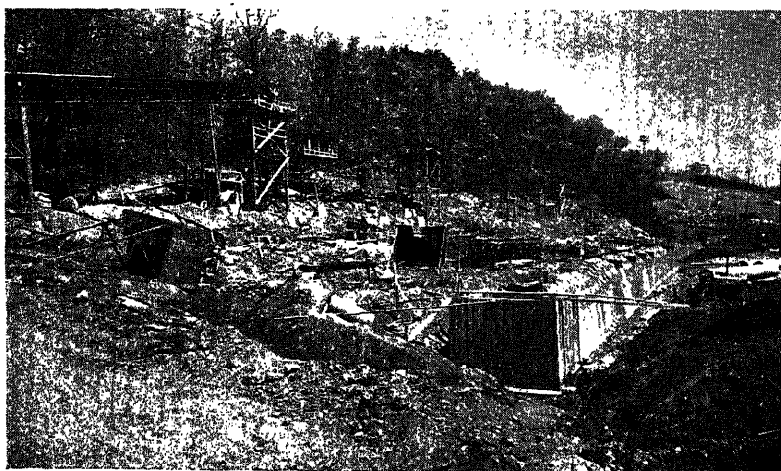
FIGURE 59.—Aggregate reclaiming tunnel under construction.

The crushed stone and manufactured sand were stacked by the aggregate contractor over a reclaiming tunnel built by the TVA (see fig. 59). The tunnel was located, as shown in figure 45, close to hill to permit the contractor to use stackers for conveying the material from his screening structures to the stock pile. Aggregates and sand were stored above the tunnel in five piles and in the following sequence, beginning from the end nearest the quarry: cobbles, coarse rock, medium rock, fine rock, and sand. The piles were spaced 100 feet on centers except the piles containing fine rock and sand where the spacing was 115 feet. With this spacing and approximately 50-foot-high piles a storage of 50,000 tons of aggregates and sand could be obtained.

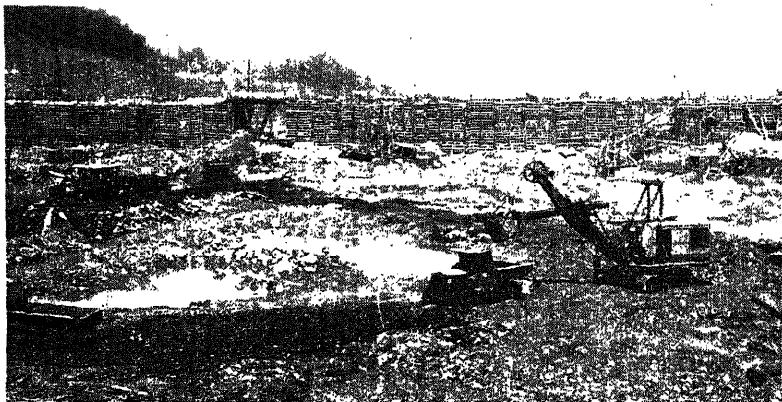
FIGURE 77.—Excavating in spillway area, looking east.

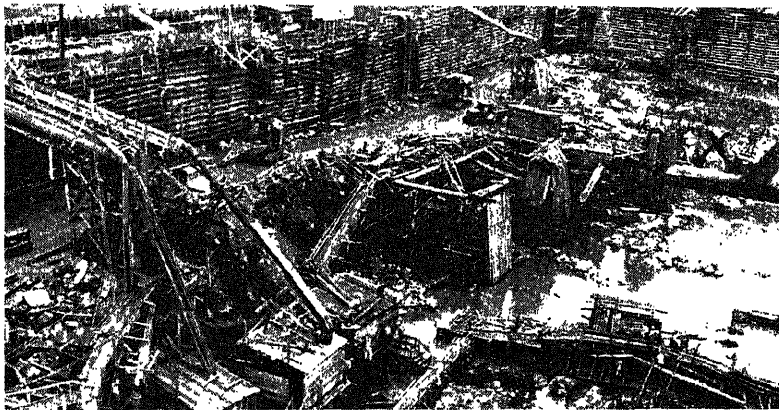
FIGURE 79.—Pumping stations along upstream arm of cofferdam.

For a considerable period, 30 pumps discharging over 100,000 gallons per minute were in constant operation to keep the cofferdam area dewatered sufficiently to permit excavation. Pumping stations were constructed at temporary sumps excavated at various points inside the cofferdam. Heavy timber shelters were erected around the pumps to prevent damage from blasting, and the water was discharged into timber flumes located on the outside of both the upstream and downstream sides of the cofferdam. These flumes carried the water to the diversion channel. Figure 79 shows the pumping stations along the upstream arm of the cofferdam.

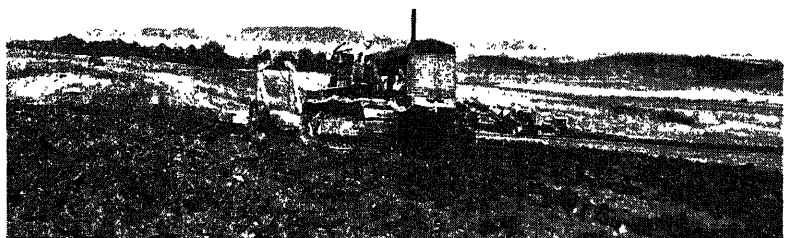
FIGURE 92.—Plowing borrow pits for loading clay.

A LeTourneau roofer pulled by a Caterpillar D-8 tractor plowed the borrow pit area for the elevating graders (fig. 92). Road graders terraced the hillside to facilitate loading on level areas and maintained the hauling roads. This permitted loading operations to be carried on at high speed and with little equipment trouble.

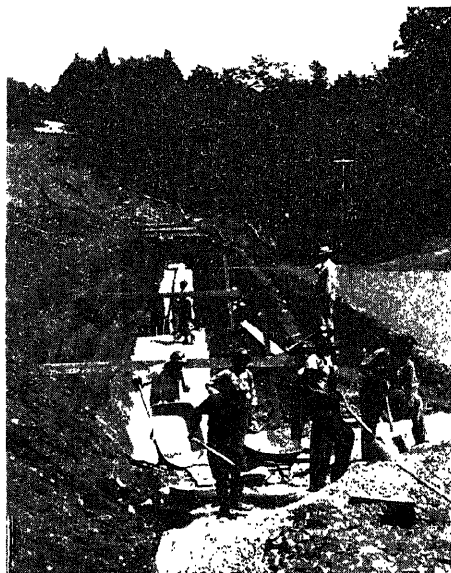
FIGURE 95.—Toe drain for saddle dams.

Drainage.—Saddle dams Nos. 1 and 3 were provided with 3-foot-thick crushed rock and sand drain blankets under the downstream third of the base areas. Eight-inch concrete drain laterals were embedded in the drain blankets with their outlets in a 12-inch concrete-pipe toe drain laid with open joints in a sand bed along the toe trench (see fig. 95).

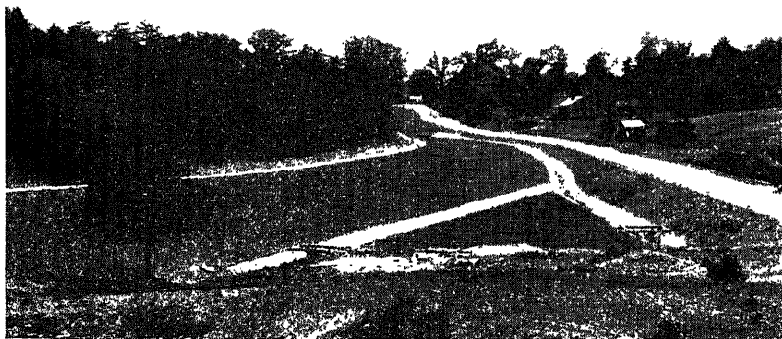
FIGURE 96.—Drainage collection ditches.

The area downstream from saddle dam No. 1 required special drainage treatment. Before construction of the saddle dam the natural drainage was eastward to the French Broad River. After the dam had been built the eastward flow of this drainage was obstructed; and it was necessary to carry the drainage westward by collection ditches (fig. 96) and a 48-inch-diameter pipe, 1,550 feet long, and discharge

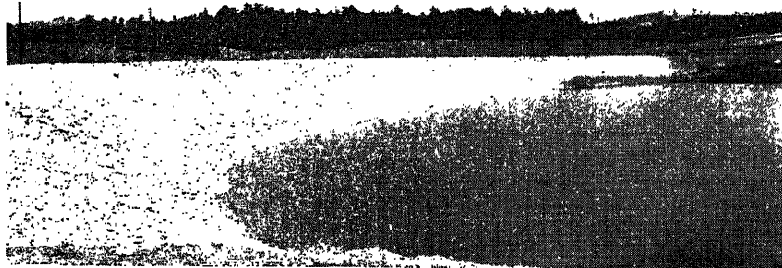
FIGURE 97.—Riprap on upstream slopes of saddle dams.

Slope protection.—The upstream slopes of the saddle dams were built on a 4.5 on 1 slope up to elevation 1000 and a 2.5 on 1 slope from elevation 1000 to the top. A 1-foot-thick blanket of crushed stone was placed on the rolled earth fill, and this was followed with a 3-foot-thick layer of riprap (fig. 97) quarried about 500 feet upstream from

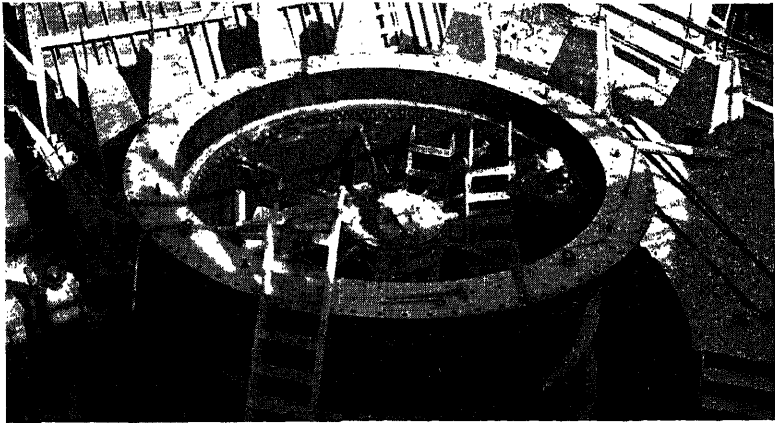
FIGURE 118.—Installing curb ring on draft tube liner.

The curb ring was also received in two half-sections, which were bolted together and set in place on the draft tube liner (fig. 118). The

curb ring was supported and leveled with eight 30-ton jack screws and seven steel H-columns with steel plates and shims.

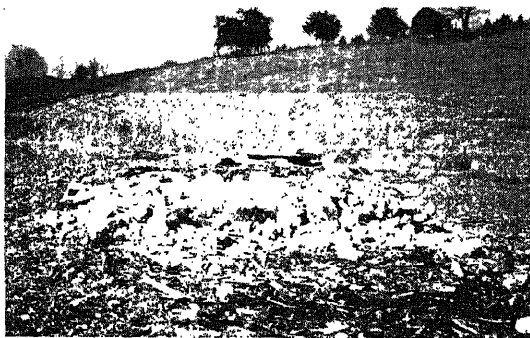
FIGURE 139.—*Silo after demolition.*

around approximately two-thirds the inside circumference of the silo. A total of 100 pounds of 40-percent dynamite was placed in these holes. When this charge was detonated the resulting blast threw the silo over on its side in the direction of the unloaded segment. The fall crushed the silo, leaving a flat pile of debris with very few jagged edges (see fig. 139.)

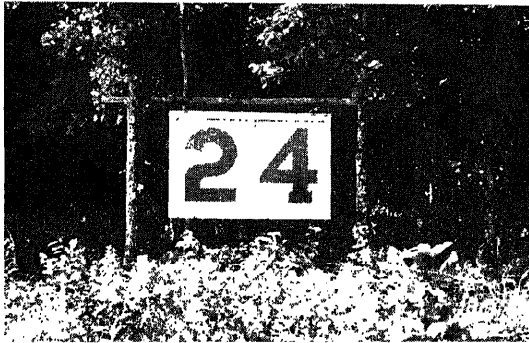
FIGURE 140.—Daymark for Douglas Reservoir.

Forty-eight daymarks were placed at strategic locations along the shore line (see fig. 140). These markers, 4 feet high by 6 feet long, have large black numerals painted on a white background. Locations of the markers with their corresponding numbers were shown on navigation maps of the reservoir, thus enabling navigators to use the maps to establish their exact position on the lake.

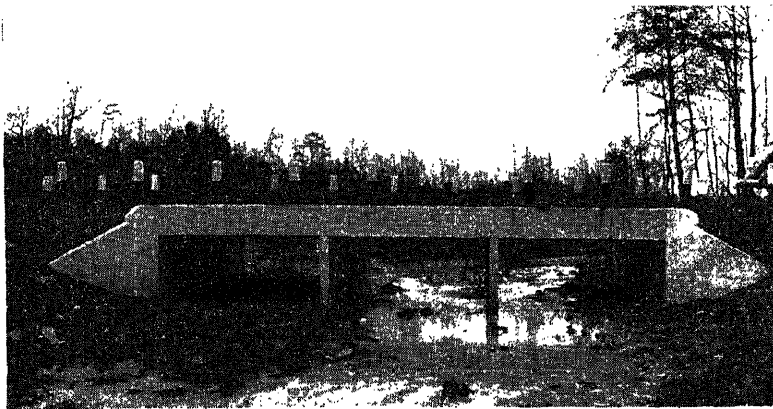
FIGURE 147.—*Seehorn Creek culvert.*

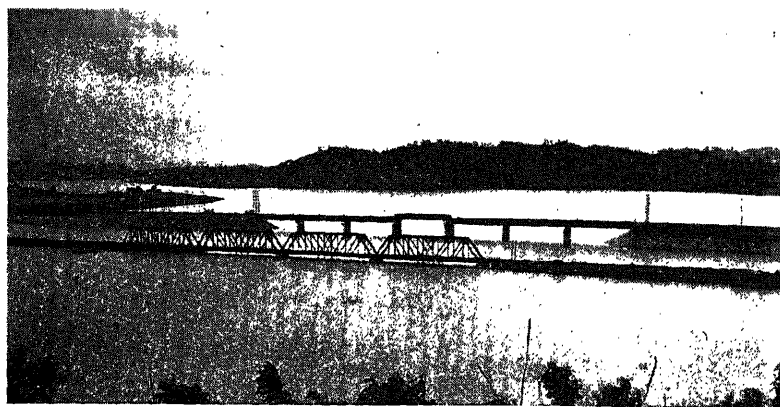
FIGURE 148.—Leadvale Bridge—Southern Railway (old bridge in foreground—before removal).

The Southern Railway track from Leadvale to Newport, extending for about 9 miles through the reservoir area, was elevated; and the railroad bridge over the French Broad River at Leadvale was raised. While several small rural communities were inundated, no highly developed residential areas were damaged to any extent.
